# 2008 Annual Inspection Report for the Weldon Spring, Missouri, Site

January 2009

## Summary

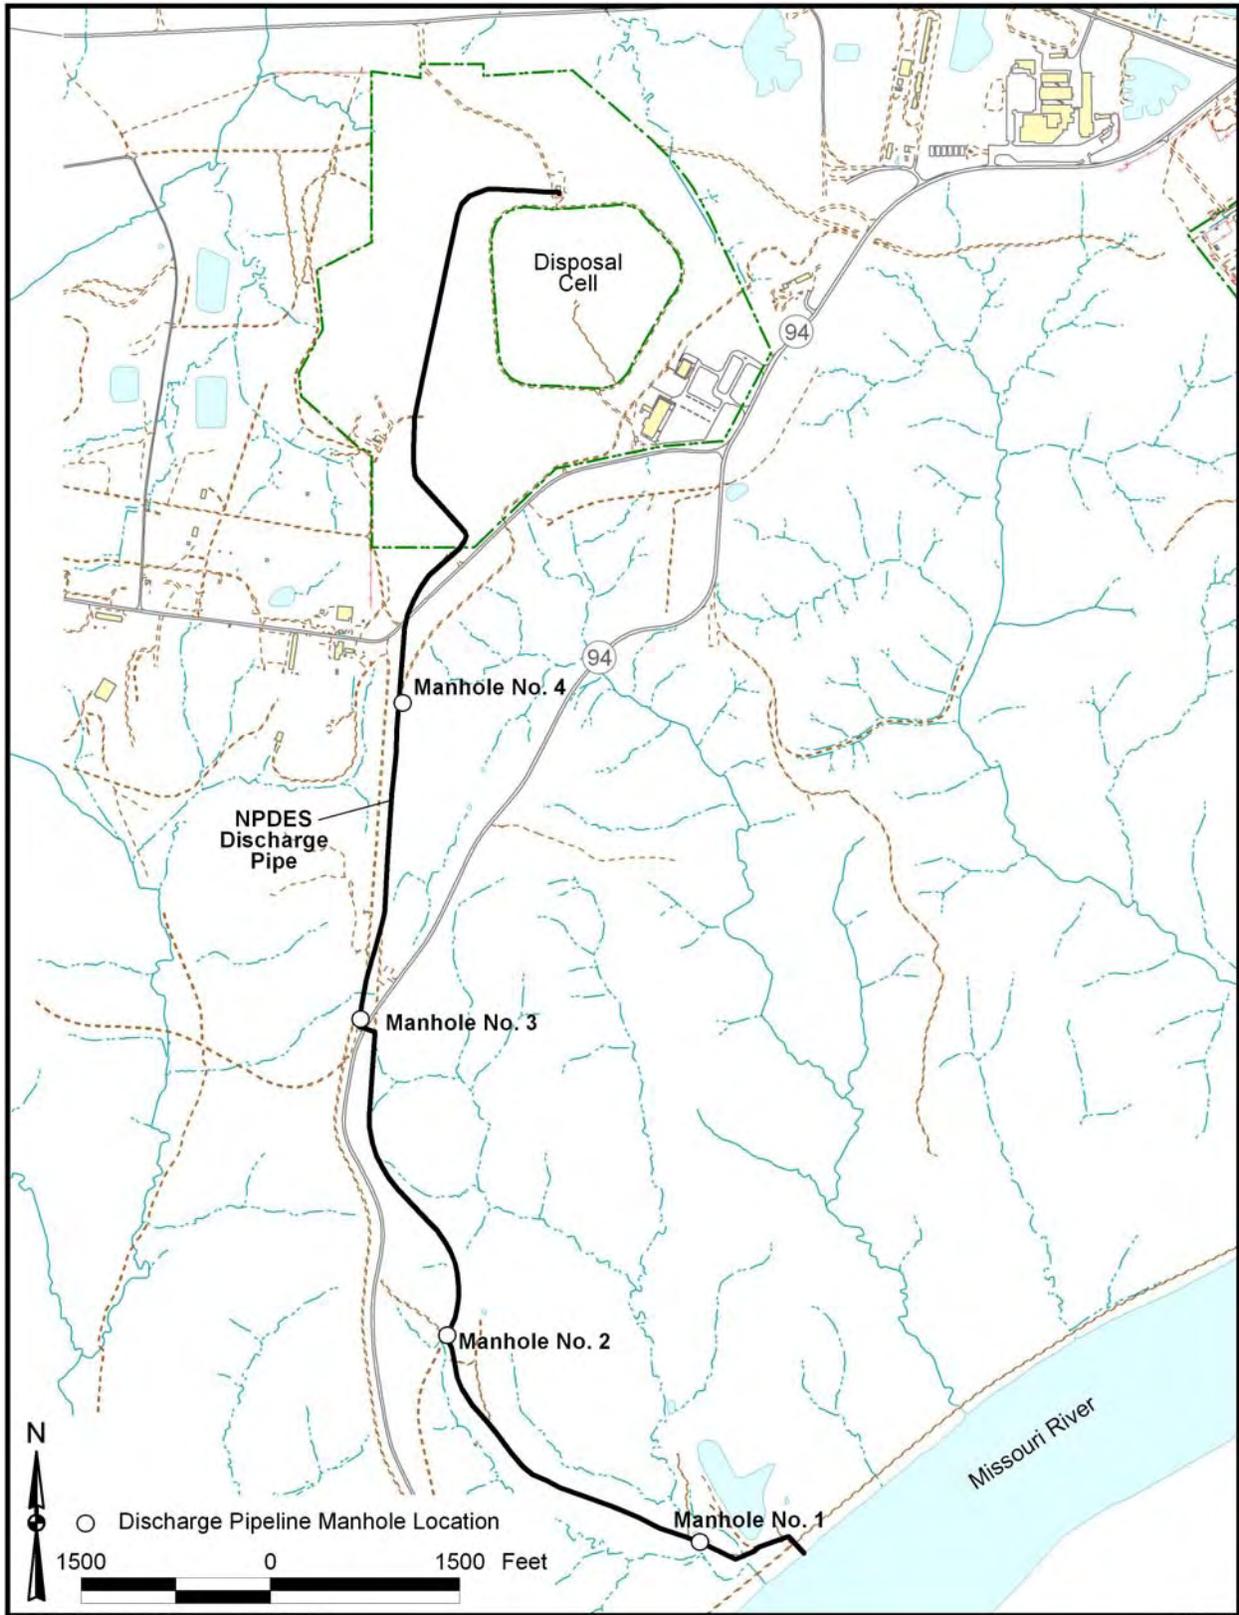
**Inspection Results:** The pipeline was inspected. GPS surveying equipment was used to find the locations of the manholes and cleanouts. A map of the pipeline, indicating the manhole locations, is shown in Figure 6. Manhole No. 1 could not be located during the 2007 inspection, although a clean-out pipe nearby was located. The pipe was located at a later date and marked. It was also located during the 2008 inspection (Photo 5). It was noted that there were no on-site disturbances of the pipeline and there were no apparent disturbances in the area of the pipeline or manholes in the off-site areas.

Figure 6. NPDES Discharge Pipeline Between the LCRS Support Building at the Missouri River, Weldon Spring, Missouri, Site

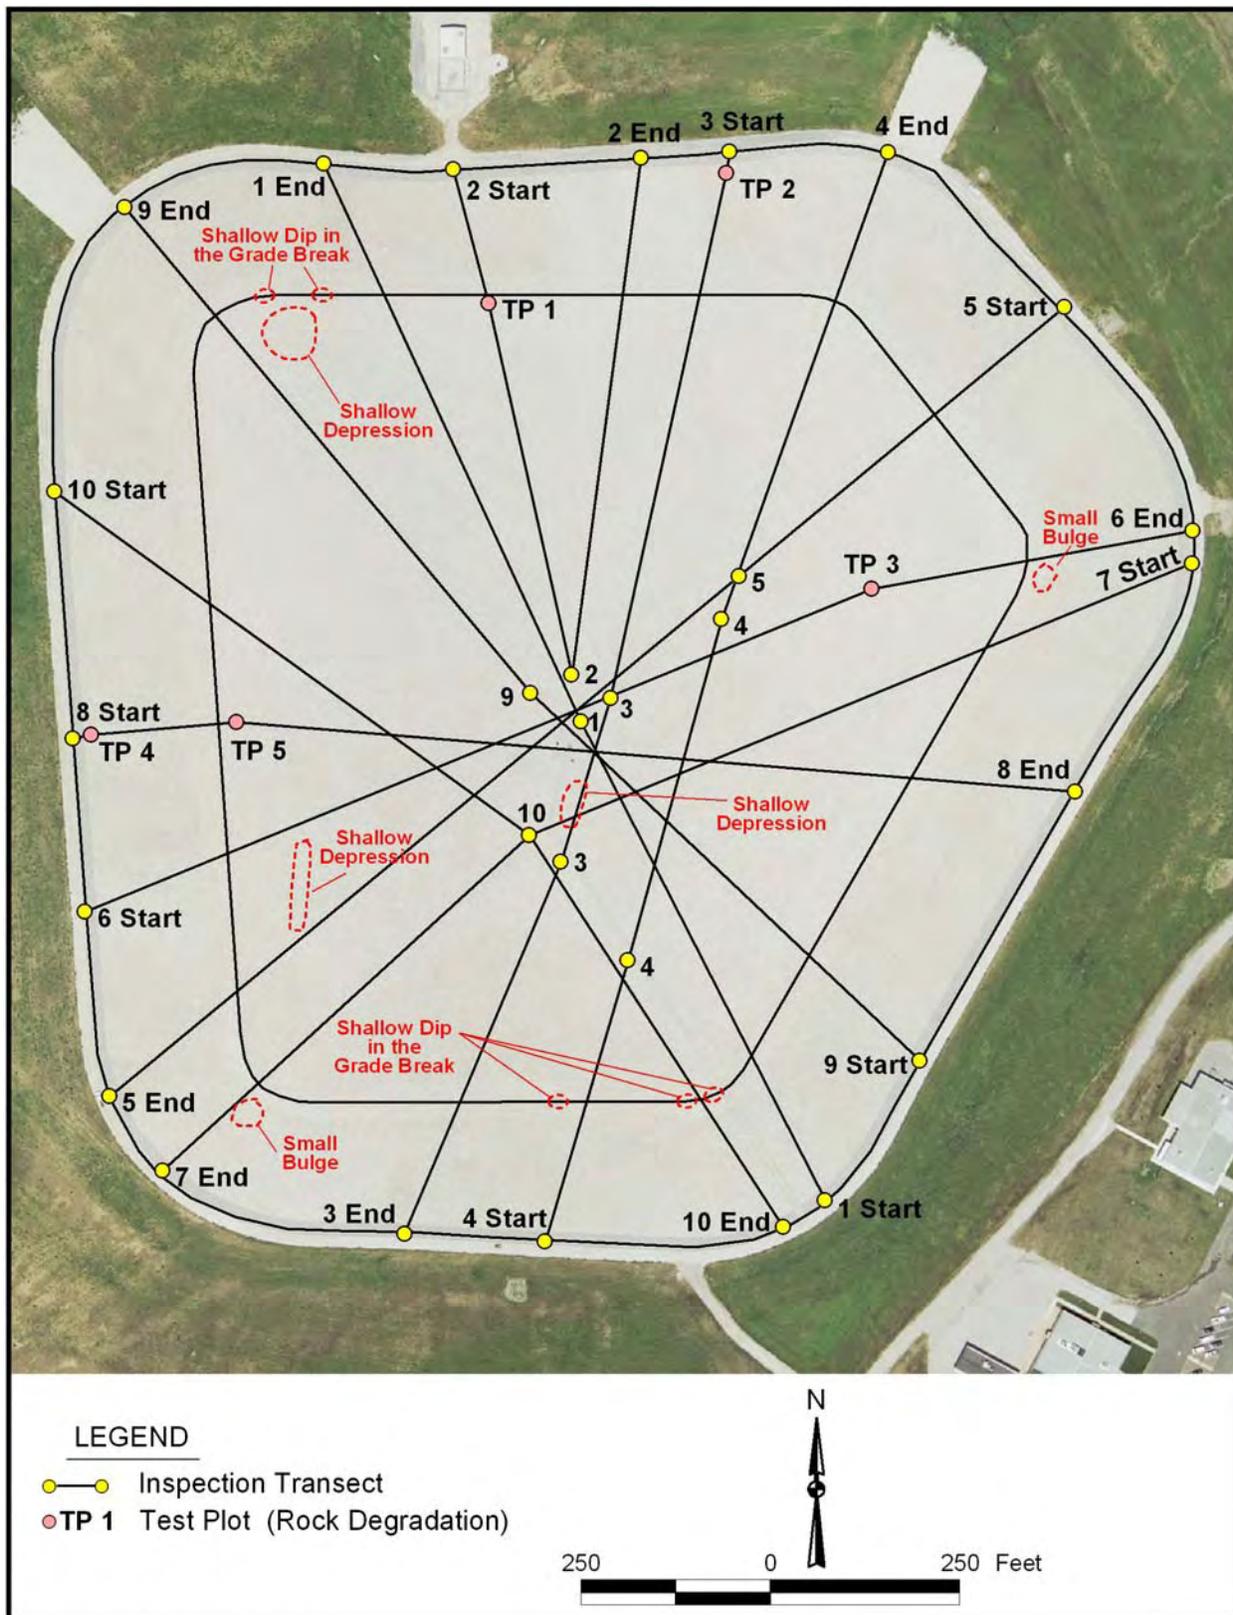
The disposal cell was inspected in accordance with the LTS&M Plan (Photos 6 and 7) and the annual inspection checklist. The cell was divided into ten transects (Figure 7). The inspectors separated into two groups and walked five transects each. The inspectors looked for depressions, shifts of cell plane vertices, and other indications of settlement. Other items for inspection were vegetation, wet areas, apron drains, guardrail, and the stairs. A GPS unit was used during the 2003 inspection to map five areas chosen for rock degradation review (Figure 7). The inspectors took photographs of these and compared them to photographs from the previous inspection of the same areas and observed no rock degradation.

Figure 7. Disposal Cell Inspection Transects and Rock Test Plot Locations at the Weldon Spring, Missouri, Site

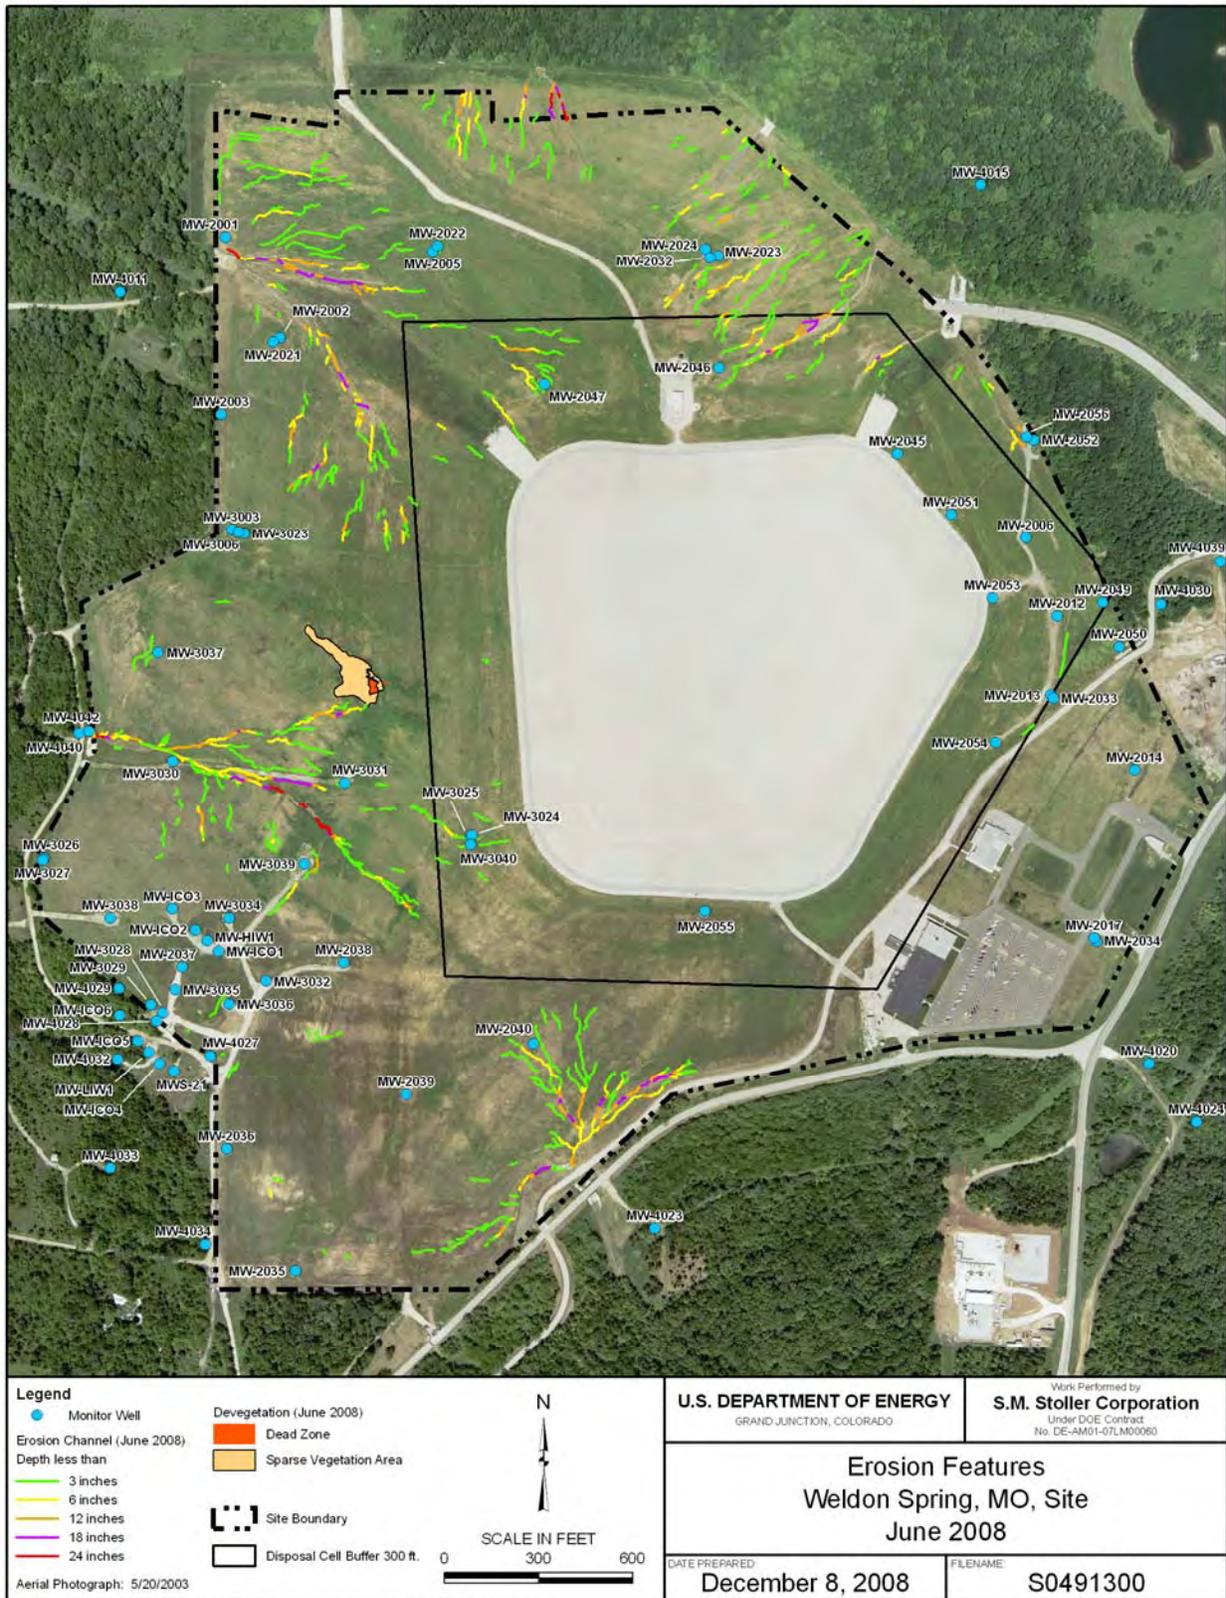
Areas of erosion in the prairie were identified during the 2006 inspection and it was recommended that the prairie be inspected more thoroughly, the erosion areas be located and mapped by GPS, and that erosion areas be repaired. Erosion channels within the entire prairie were mapped with GPS in August 2007 and again in June 2008 (Figure 8). The resulting information will be used to track the nature and extent of erosion in the future.

Figure 8. Erosion Channels Within the Prairie

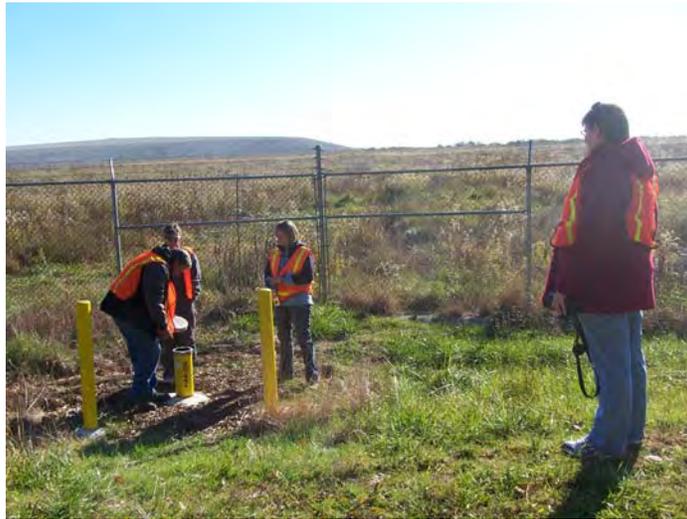
*Photo 2. Monitoring well MW-4042 on the Army property.*

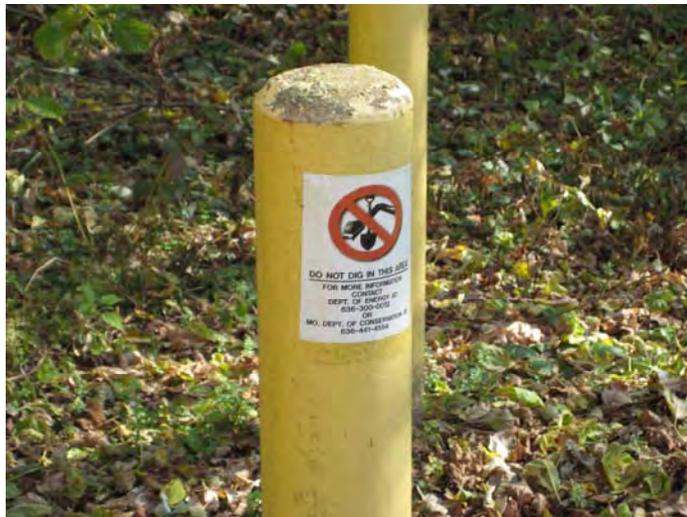
**Inspection Results:** The Quarry reduction zone area was inspected and no indications of excavation into soils and bedrock were observed. As required by the final LTS&M Plan, information signage and contact numbers were posted on monitoring wells at the Quarry Area reduction zone. The labels indicate no digging is allowed in this area and include contact numbers for DOE and MDC. During the 2007 inspection, it was decided to purchase a more permanent manufactured type label. These were noted during the 2008 inspection (Photo 3). It was noted that the majority of the labels did not face the trail and this should be corrected. Land use remains consistent with planned institutional controls.

*Photo 3. "No Dig" labels on wells at Quarry Reduction Zone.*

- 2. Recommendation:** Have the “No Dig” labels on the Quarry reduction zone wells placed so they can be seen from the Katy Trail.

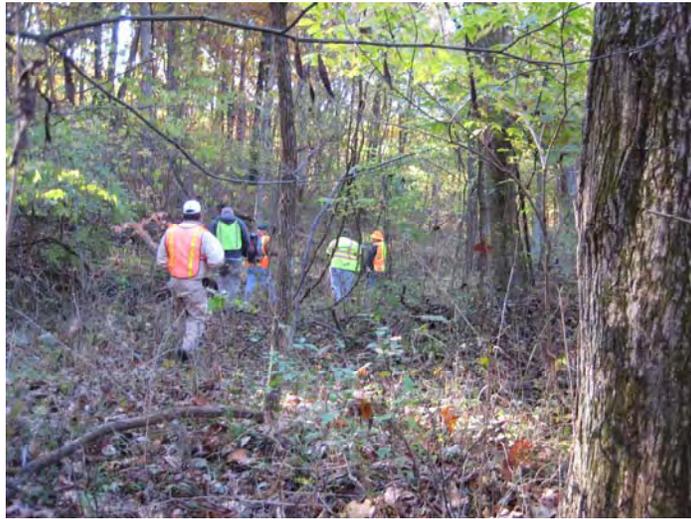
**Inspection Results:** The inspectors walked down the entire Southeast Drainage (Photo 4) and no indications of residential use, construction, or any other activity that would indicate non-recreational use of the area were observed. The springs also were inspected and no indications of residential, commercial, or agricultural use of the springs were observed. Both of the springs were observed to be flowing. Current land use remains consistent with planned institutional controls.

*Photo 4. Southeast drainage.*

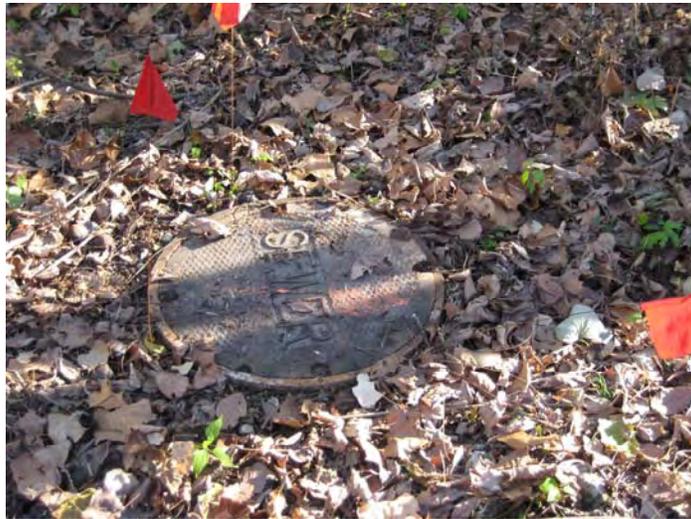
*Photo 5. Manhole #1 on LCRS pipeline.*

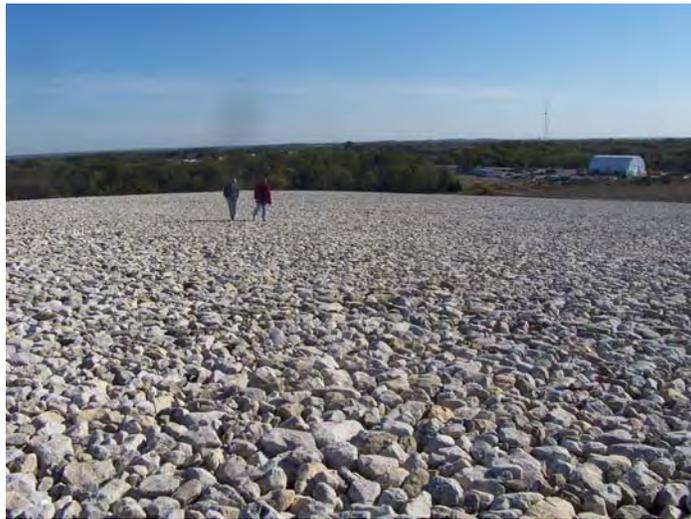
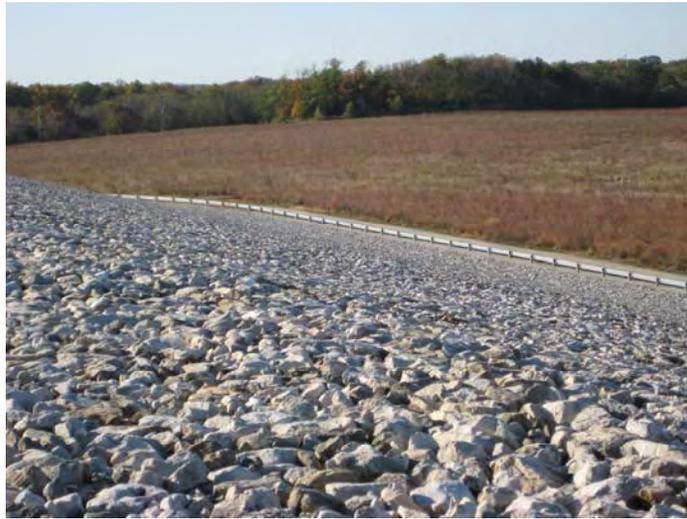
*Photo 6. Disposal cell inspection looking northeast.*

*Photo 7. Disposal cell looking southwest.*

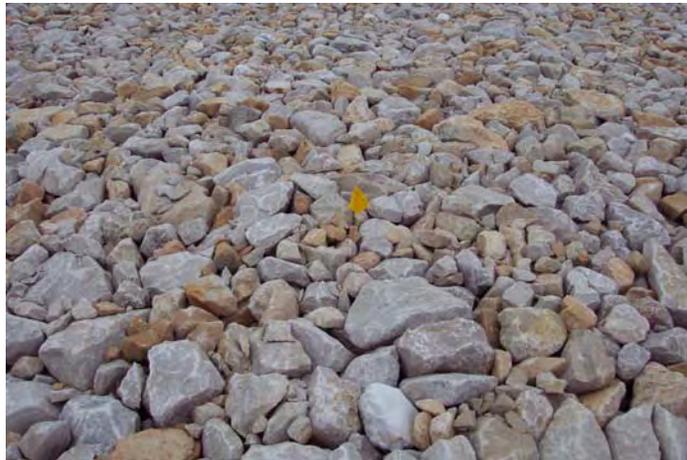
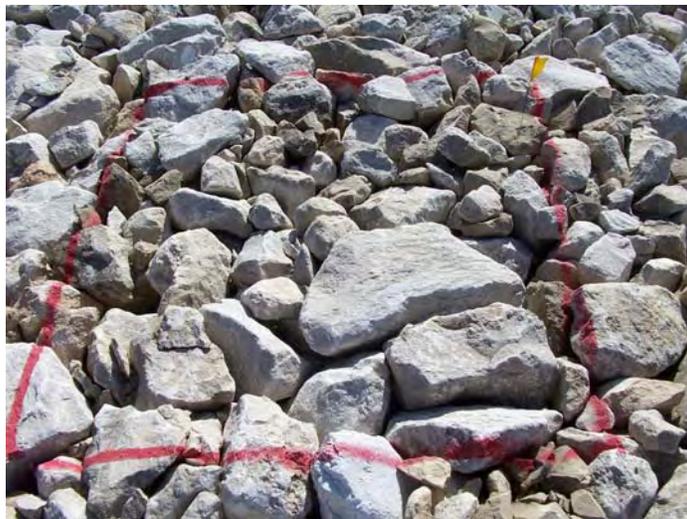
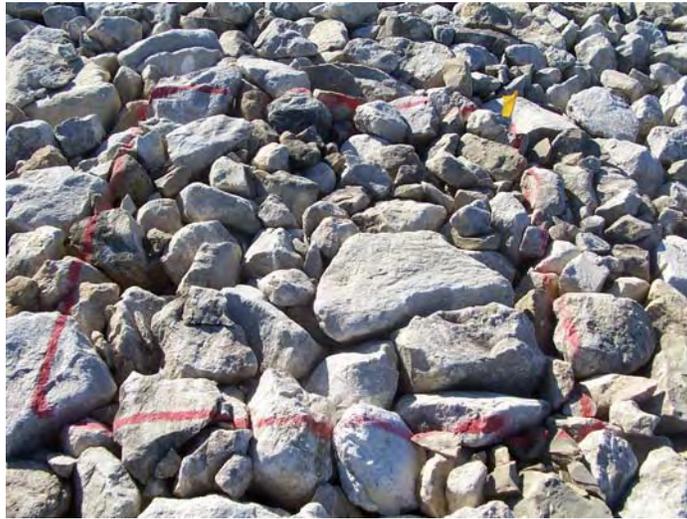
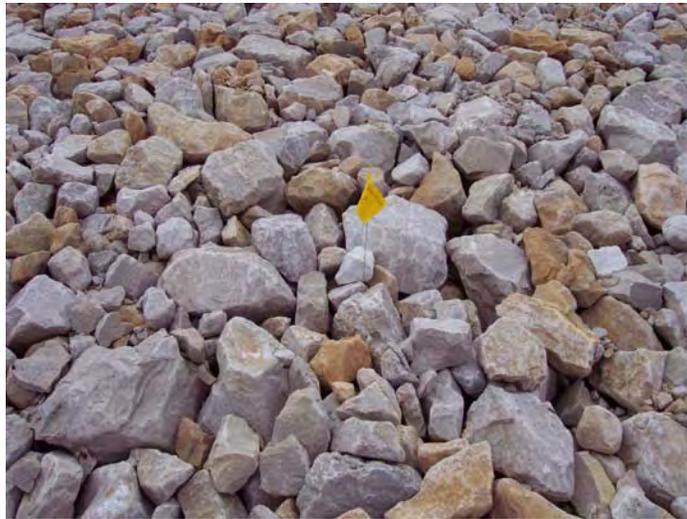
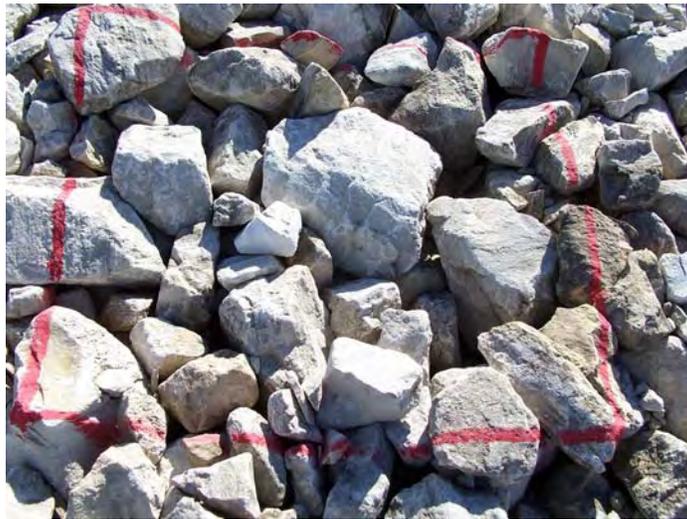
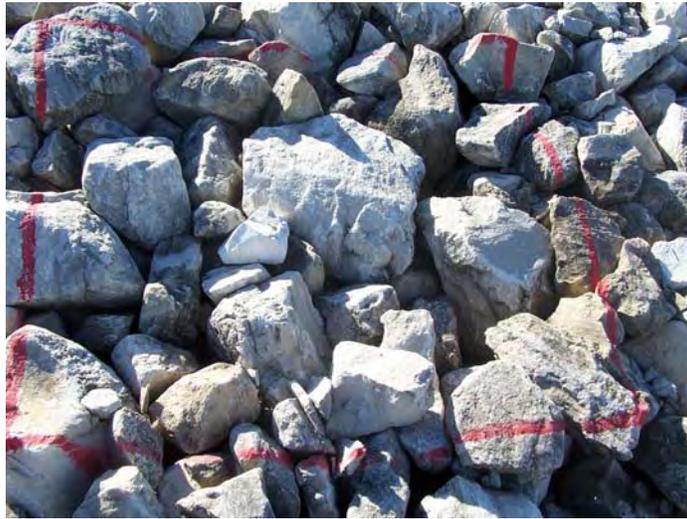
It was noted during the 2007 inspection that the Test Plot 3 painted area was in the wrong location and this had been accounted for in previous years by using the photo for comparison. This was corrected during 2008 and noted during the inspection. These areas are shown from the original inspection in 2003, last year, and this year for comparison in Photos 8 through 22.

*Photo 8. Cell cover rock test plot TP1; north edge north facet (2003 Inspection).*

*Photo 9. Cell cover rock test plot TP1; north edge of north facet (2007 Inspection).*

*Photo 10. Cell cover rock test plot TP1; north edge of north facet (2008 Inspection).*

*Photo 11. Cell cover rock test plot TP2; north edge north facet (2003 Inspection).*

*Photo 12. Cell cover rock test plot TP2; north edge north facet (2007 Inspection).*

*Photo 13. Cell cover rock test plot TP2; north edge north facet (2008 Inspection).*

Remarks The 5 Rock Test Plots were compared to previous photos. The rocks in the test plots had not degraded or changed from previous years.

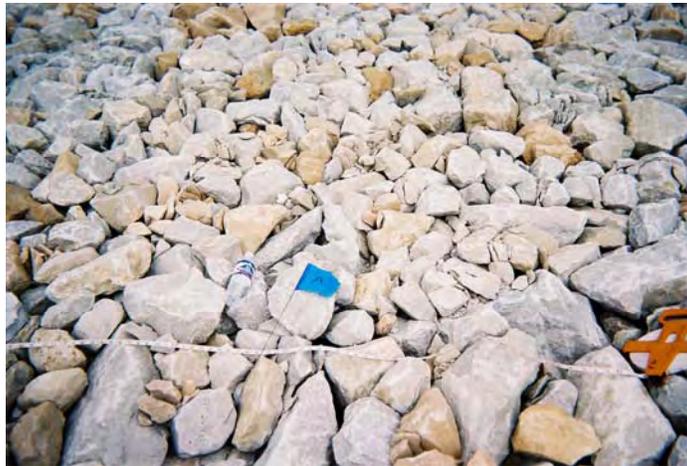
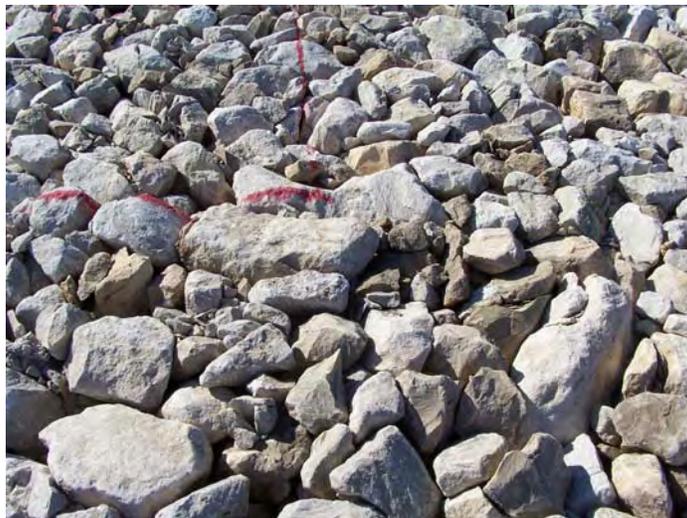
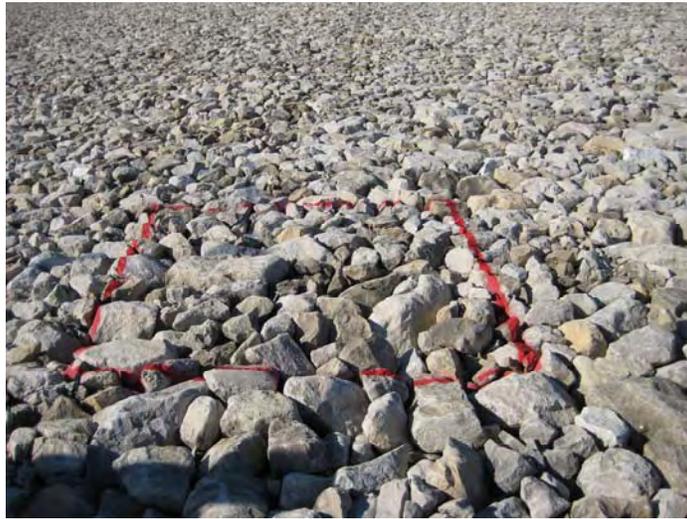
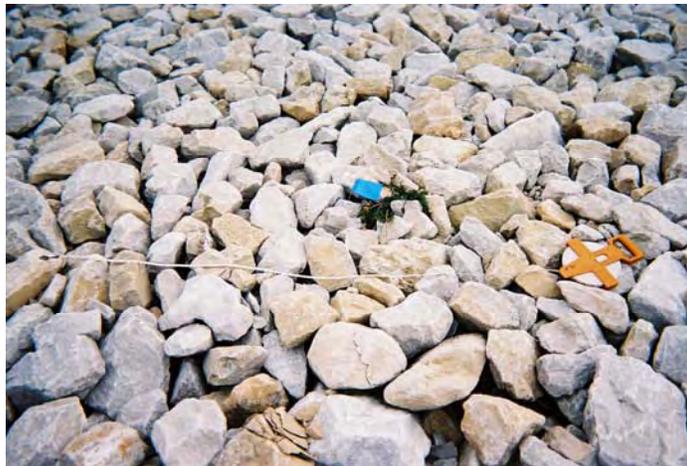
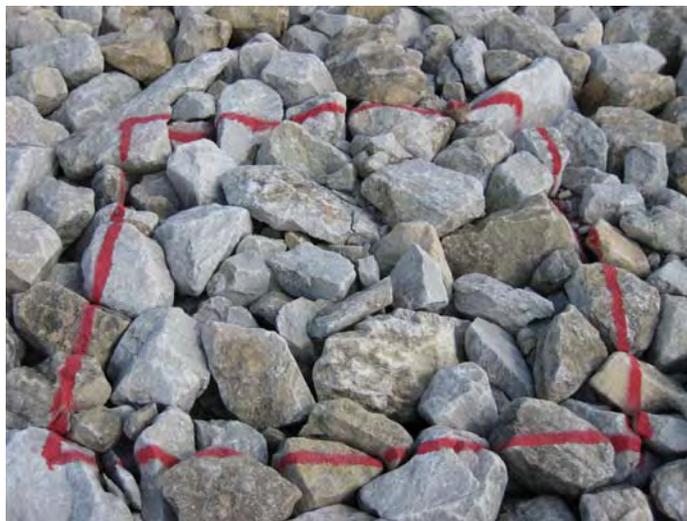
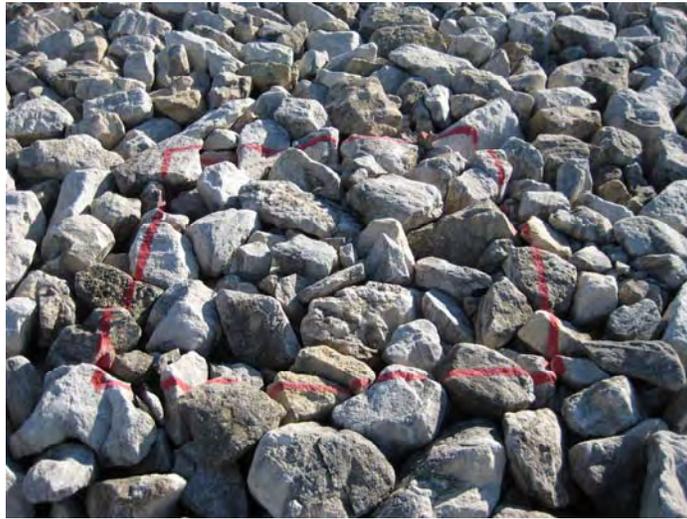
*Photo 14. Cell cover rock test plot TP3; northeast ridgeline (2003 Inspection).*

*Photo 15. Cell cover rock test plot TP3; northeast ridgeline (2007 Inspection).*

*Photo 16. Cell cover rock test plot TP3; northeast ridgeline (2008 Inspection).*

*Photo 17. Cell cover rock test plot TP4; located on upper west side (2003 Inspection).*

*Photo 18. Cell cover rock test plot TP4; located on upper west side (2007 Inspection).*

*Photo 19. Cell cover rock test plot TP4; located on upper west side (2008 Inspection).*

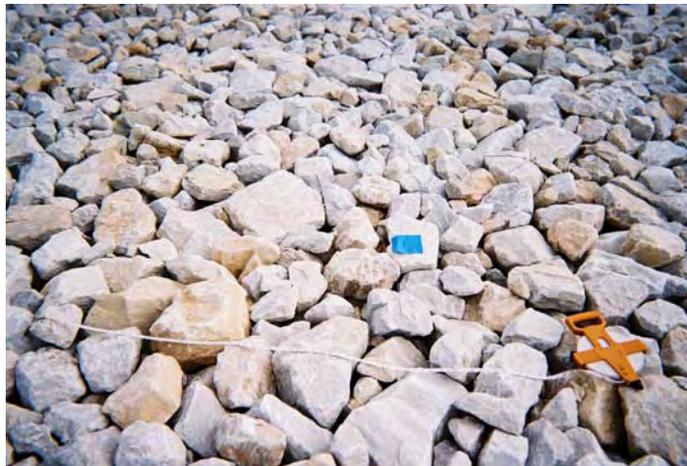
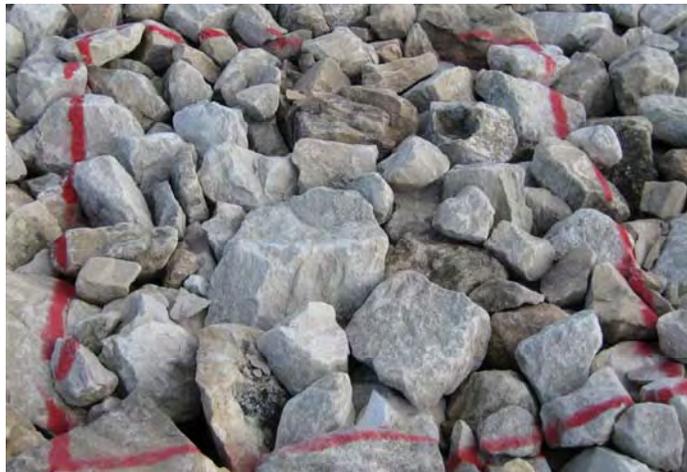
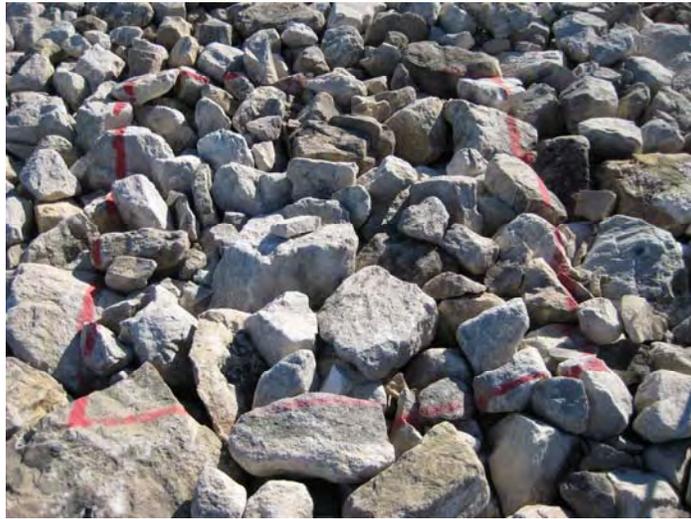
*Photo 20. Cell cover rock est plot TP5; located on lower west side (2003 Inspection).*

*Photo 21. Cell cover rock test plot TP5; located on lower west side (2007 Inspection).*

*Photo 22. Cell cover rock test plot TP5; located on lower west side (2008 Inspection).*

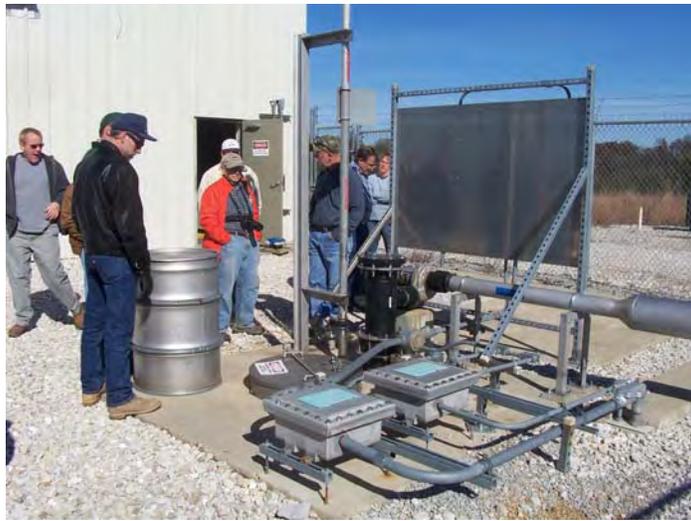
Operations of the LCRS were discussed with site personnel and the system was inspected (Photo 23). The system had been reconfigured and the building housekeeping had been improved during 2008. This was mainly possible due to the hiring of 2 new full-time personnel during the last year and a half. The fences and doors were locked and in good condition. The system was functioning as designed. The LCRS data and documentation were reviewed during the document review period of the inspection and the following information was checked and verified that it was available: sampling data, LCRS flow rates, action leakage rate information, “burrito” system flow rates, and leachate data. As required by the LTS&M Plan, the leachate production rates, analytical results, and disposal information are provided in Appendix D.

*Photo 23. LCRS sump area.*

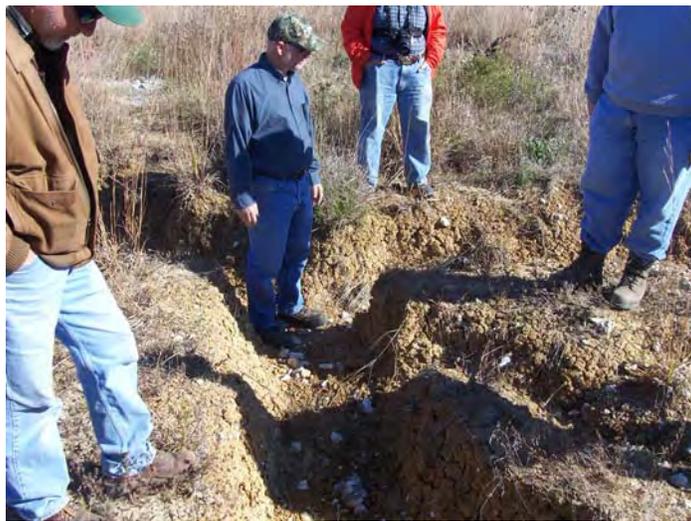
It was noted during the 2008 inspection that some areas of erosion had worsened (Photo 24) and that in other areas vegetation had taken over the erosion areas considerably. The erosion will continue to be monitored and another mapping and evaluation is scheduled for the spring/early summer 2009.

*Photo 24. Erosion areas on the south side of disposal cell.*

- 3. Recommendation:** Continue to monitor and evaluate erosion on the Chemical Plant Site.
